Manhole Inspection Summary

Manhole # S31EE2019MH

Insp Date: **1/9/07 10:03 AM**

Location Address: **20 AINSLEY GRTH**

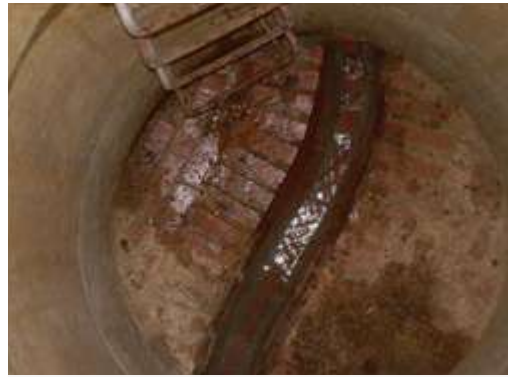
Top View

☐ Parged ☒ **Debris** (not Condition related)

Bench debris.

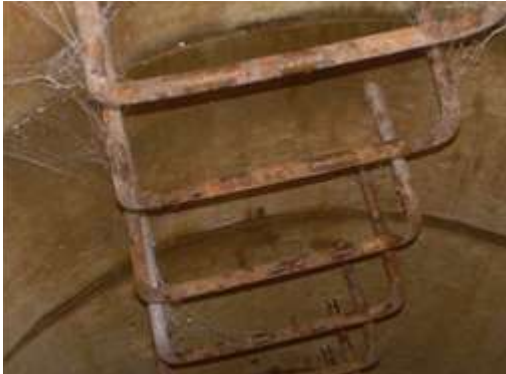
Defect

Infiltration: ☐ None ☒ **Joint** ☐ Cracks ☐ Mortar ☐ Roots ☐ Wall

Corbel and Barrel infiltration.

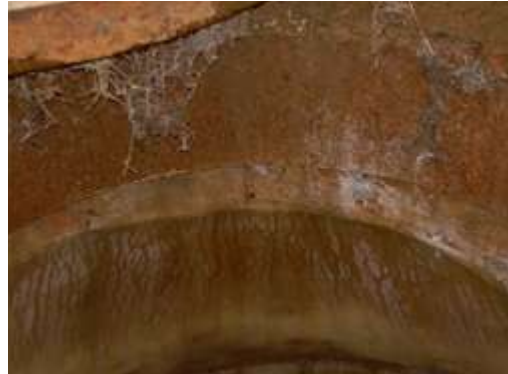
Defect

Infiltration: ☐ None ☒ **Joint** ☐ Cracks ☒ **Mortar** ☐ Roots ☐ Wall

Adjustment and Corbel infiltration.

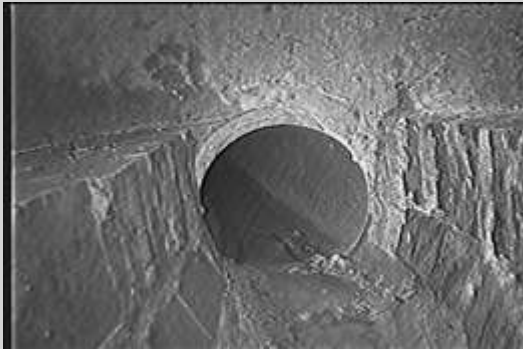
8 in. Circular Gravity Sewer Pipe Out @ 12 O'Clock

Deposits: ☐ None ☐ Mud ☐ Sludge ☐ Debris ☒ Grease

Silt Depth: **0** (in.) Deposits Extent: **Light**

Infiltration: **Evidence** Pipe Seal Cond: **Cracked**

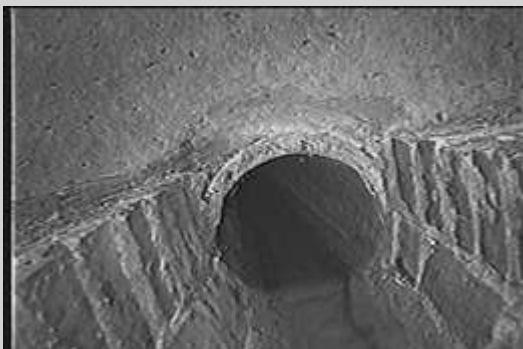
8 in. Circular Gravity Sewer Pipe In @ 7 O'Clock

Infiltration: **Evidence** Pipe Seal Cond: **Unknown**
